## SEWAGE COMPLIANCE INSPECTION REPORT

NPDES / WQM Permit No. <b>PA0026077</b>	Mo/Day/Year <b>7-31-2019</b>	Entry Time <b>1215</b>	Exit Time <b>1700</b>	Inspection Type <b>INCDT</b>	eFACTS Inspection ID <b>2920137</b>
Facility Name: <b>Carlisle Regional Water Pollution Control Facility</b>		Permittee Name: <b>Carlisle Borough</b>			
Physical Location/Directions: <b>54 N. Middlesex Road Carlisle, PA 17013</b>				Permit Expiration Date: <b>10-31-2022</b>	
Municipality: <b>Middlesex Township</b>		County: <b>Cumberland</b>		Permit Renewal Application Due: <b>4-30-2022</b>	
Facility Type: <input checked="" type="checkbox"/> Municipal <input checked="" type="checkbox"/> Major <input type="checkbox"/> Non-Municipal <input type="checkbox"/> Minor		Treatment Process: <input type="checkbox"/> Ext Aeration <input type="checkbox"/> Contact Stabilization <input type="checkbox"/> SBR <input type="checkbox"/> RBC <input type="checkbox"/> MBR <input type="checkbox"/> MBBR/IFAS <input type="checkbox"/> Trickling Filter <input type="checkbox"/> Lagoon <input type="checkbox"/> Other:

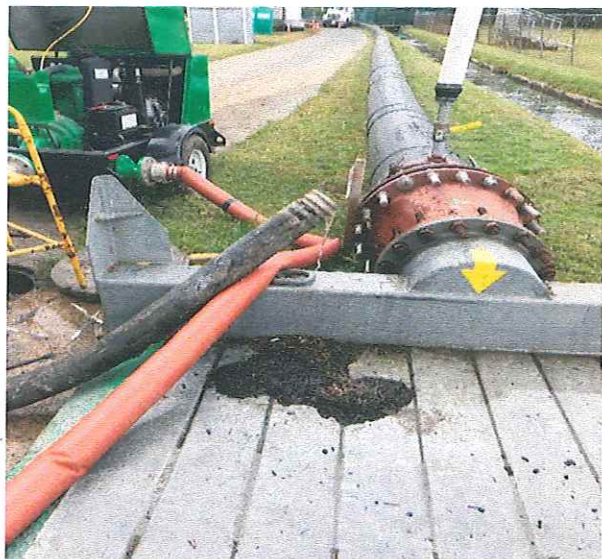
At manhole 437, a trailered pump unit was observed with raw wastewater being discharged from a black pump hose that was open and leaning on the guardrail for a walkway crossing the stream channel. The black pump hose was previously used in the manhole to evacuate residual sewage and/or process water from the lining process to the bypass sewage line. The effluent connection on the pump was an orange hose running approximately 50 feet to a valve connection on the bypass line. The discharge from the black hose was spilling onto the walkway and was flowing out over ground with portions of the flow going to the stream channel and some back down into the manhole. One of the Ric-Man crew was made aware of the situation and moved the hose back down into the manhole. A grab sample was collected for field tests of the discharge. The field test results were pH = 7.93 S.U., Do = 0.23 mg/L, and the temperature = 32.2° C. The crewmember stated that they had been working in the manhole 30 minutes prior.

Photograph taken by Officer Thurner-Diaz of the PA Fish and Boat Commission of the unpermitted discharge of raw sewage from pump hose

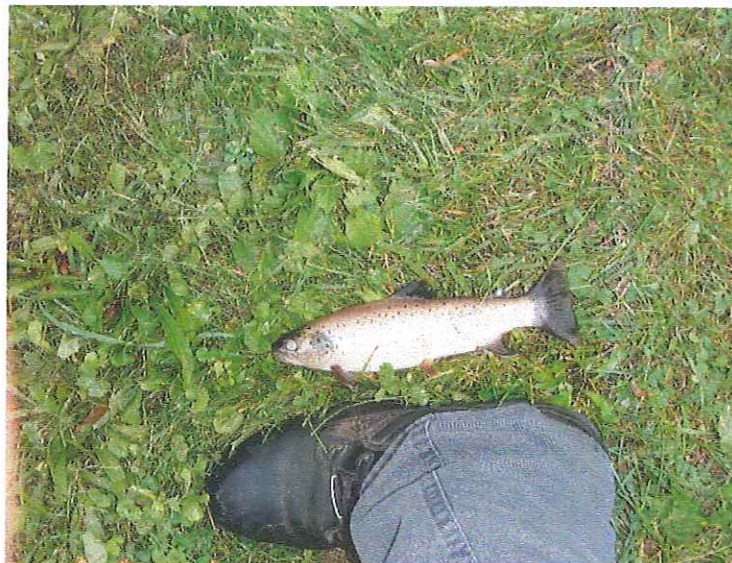
Immediately upstream of the injection site, the Letort Spring Run (Letort) separates with a portion of the flow conveyed into a man-made channel approximately 4' wide and 4' deep. There was numerous dead trout and minnows observed from 50' downstream of the injection site and continuing past Barry Drive to the Post Road crossing. Estimated numbers for dead fish were >100 in the 0.3-mile stretch of the man-made channel. A visual inspection of the Letort Spring Run (main stem) downstream of the split for the man-made channel was conducted with no dead fish observed. The Letort branches a second time and additional flow is released over a small dam and flows back towards the man-made channel, just past Ashburn Drive. In that segment of the Letort, no dead fish of any type were observed. One live golden rainbow (~14") was seen swimming upstream of the dam spillway. This segment of the Letort was not directly downstream of the injection work site.

Picture taken by Michael Benham of dead trout removed from channelized portion of Letort Spring Run upstream of manhole 437

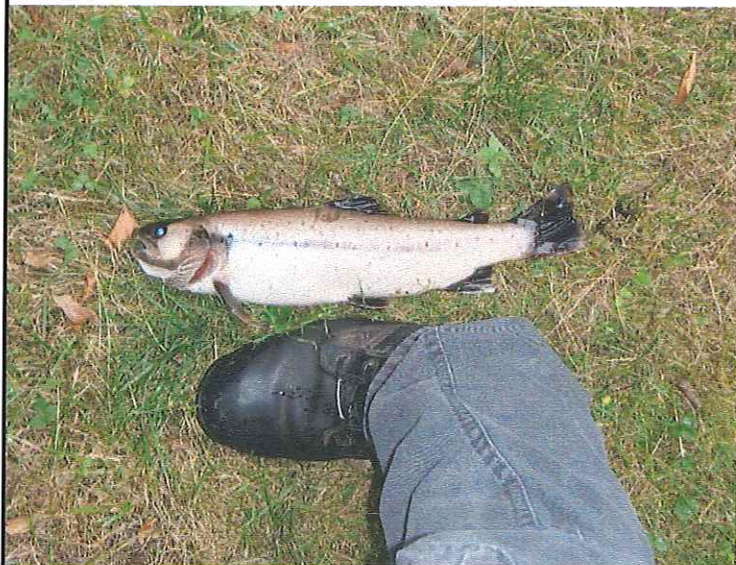
Picture taken by Michael Benham of dead trout removed from channelized portion of Letort Spring Run near Barry Drive. Boot shown is 10.5 inches.
